**NASA CR-72850**

# **EVALUATION OF HIGH TEMPERATURE ELECTRICAL MATERIALS AND COMPONENTS**

**A. J. Krause, W. S. Neff and J. W. Toth**

**Westinghouse Electric Corporation  
Aerospace Electrical Division  
Lima, Ohio**

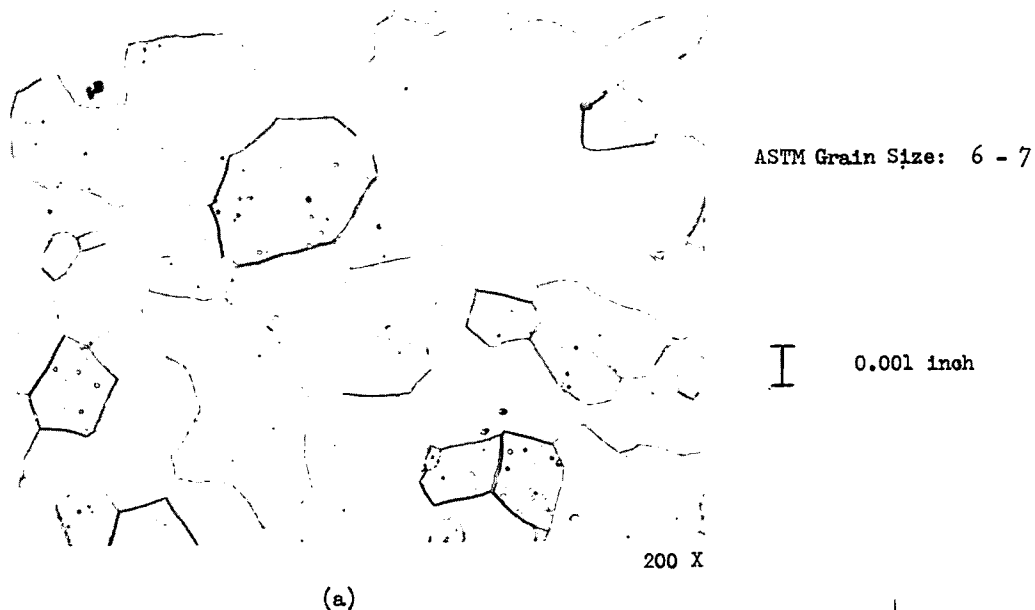
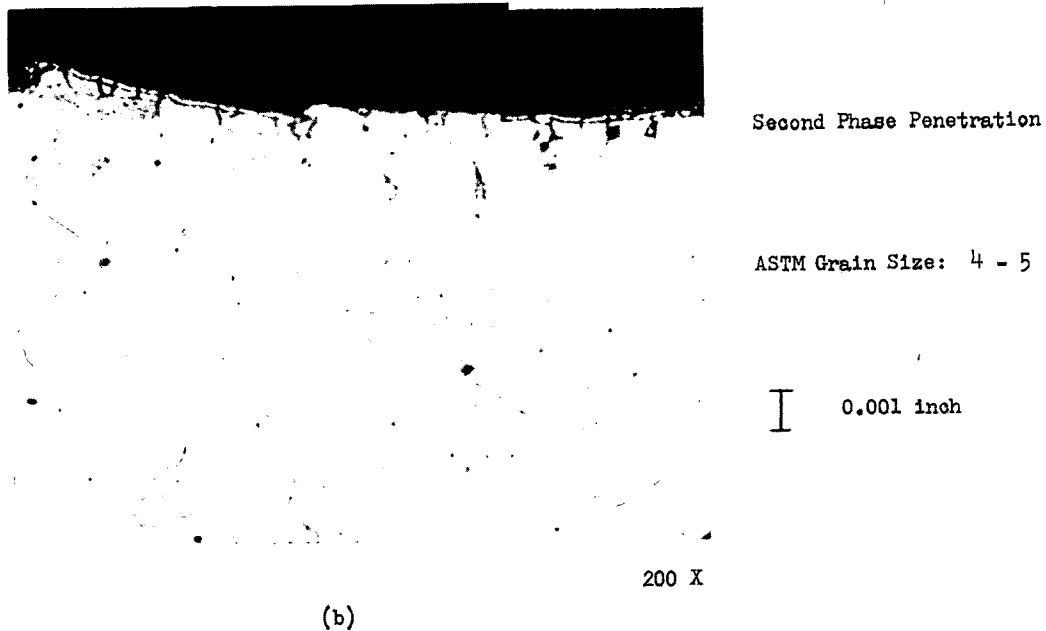
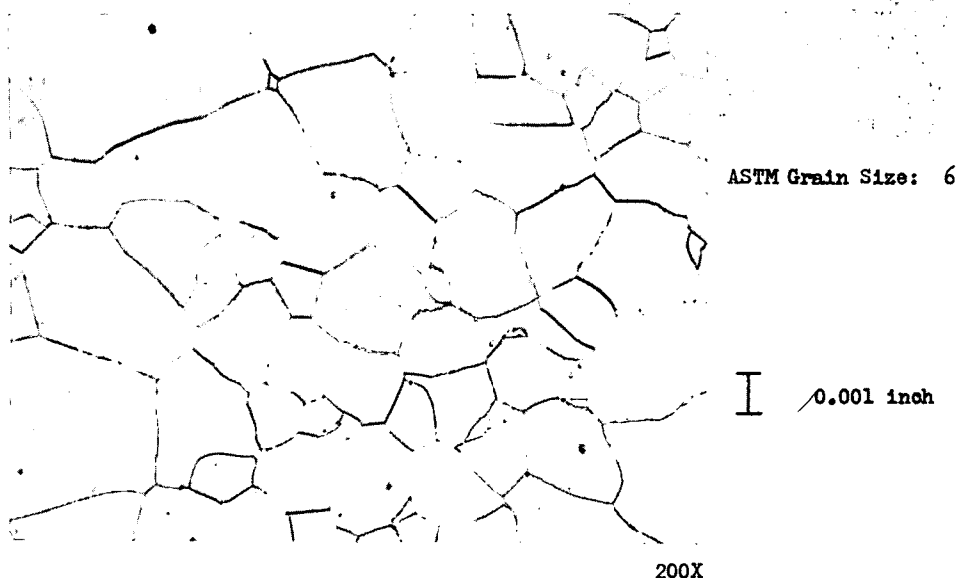
The microstructure of sections from solenoid end bells and plungers were examined and compared with a specimen from the unaged iron-27% cobalt forged bar. Representative microstructures are shown in figures 52 and 53. Some grain growth is evident in the iron-27% cobalt plunger (figure 52(c)) from the continuously energized solenoid, number 3, (aged 5000 hours at

1300° F as compared to the unaged forging (figure 52(a)). The plunger specimen from the intermittently energized solenoid, number 4, (aged 5000 hours at 1050° F and 5000 hours at 1190° F) exhibits still larger grain size (see figure 52(b)). There is evidence of a slight penetration by a second phase at the surface of the specimen shown in figure 52(b). This second phase is probably iron oxide.

Figure 52. - Photomicrographs of Forged Iron-27% Cobalt Magnetic Alloy from Solenoids Before and After 5000-Hour Thermal-Vacuum Exposure. (200X)

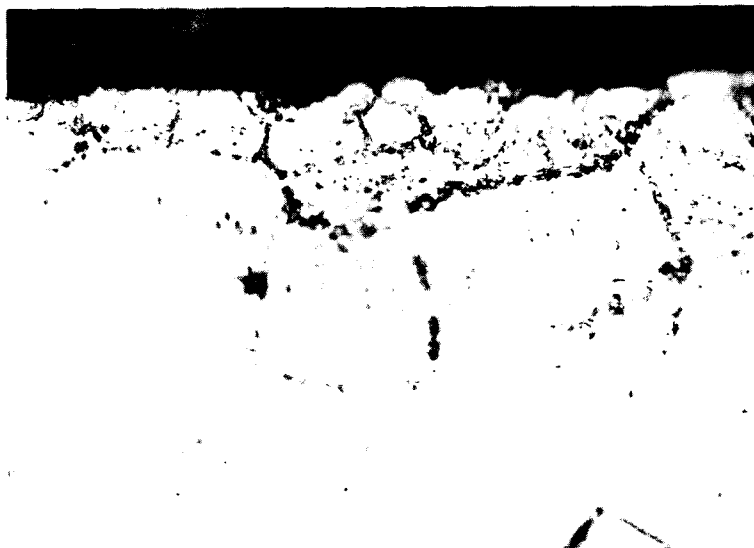
Results of long term contact between boron nitride fiber cement and iron-27% cobalt iron are exhibited in figure 53(b). At a magnification of 700X, a slight second phase penetration along the grain boundaries may be noted in the part of end bell that had been in contact with boron nitride cement insulation during the 5000-hour test at 1300° F. The diffusing phase may be a

Black Scale on Outside  
Surface of End Bell

Second Phase Penetration

Figure 53. - Photomicrograph of Thermally Aged Iron-27%  
Cobalt End Bells From Solenoid No. 3  
Showing Second Phase Penetration Near  
Boron Nitride Fiber Cement Insula-  
tion. (700X unetched)

boride. Figure 53(a) representing an outer bell surface, shows little evidence of second phase penetration. An oxide layer may be seen on the end bell surface.

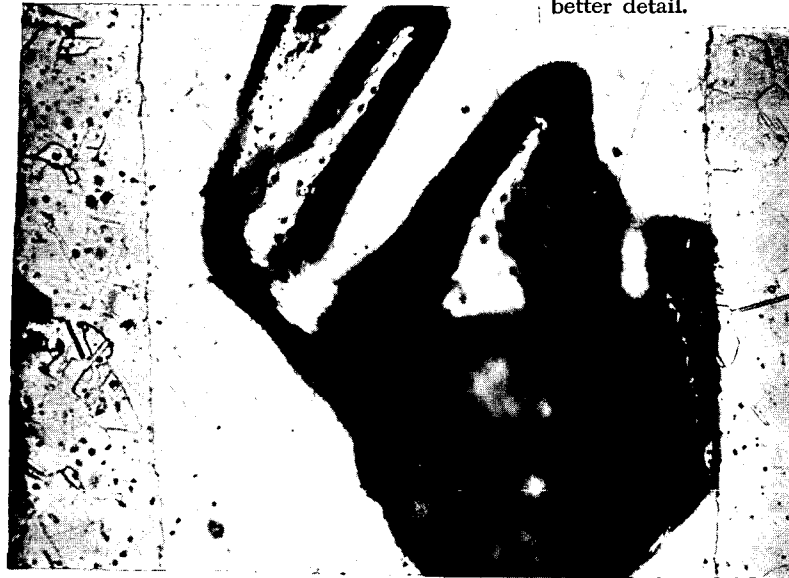
Figure 54. - Photomicrograph of the Electrical Conductor of the Intermittently Energized Solenoid After 5000-Hour Thermal-Vacuum Exposure. (200X)

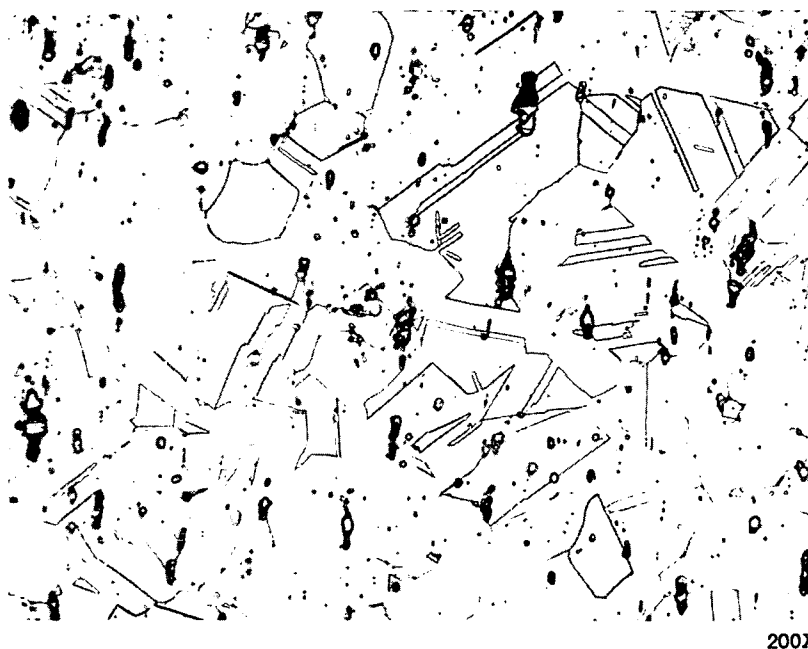
Construction Material Examinations. - Solenoid construction materials were given visual examinations. The stop plate from the continuously energized solenoid and unaged material were subjected to metallographic examinations and were compared. Figures 56 and 57 show microstructures of the unaged and aged materials respectively. The unaged material has the normal annealed face centered cubic structure while the aged material exhibits a face centered tetragonal structure probably mixed with a close packed hexagonal structure. However to verify this, electron diffraction studies will be necessary. Visual examination of the solenoid weights revealed no degradation occurred in thermal aging. No degradation was found in the examination of the 321 stainless steel O-ring.

Figure 56. - Photomicrograph of Unaged Solenoid Stop Plate Material. (200X)
